## Cimarron HOA Vancouver, WA

Report #: 32403-0  
Beginning: January 1, 2027  
Expires: December 31, 2027

# RESERVE STUDY "Full"

June 22, 2026

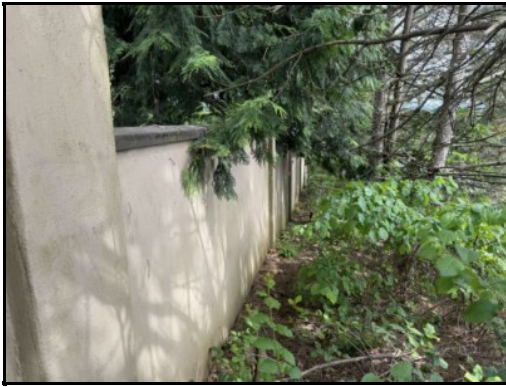
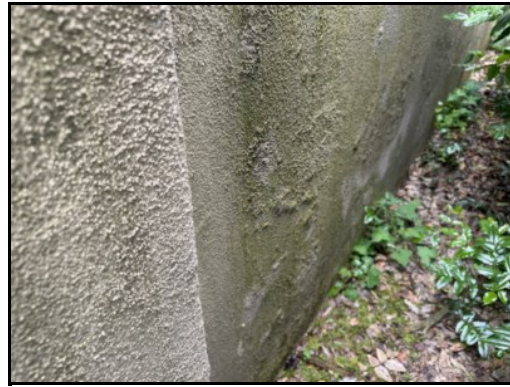
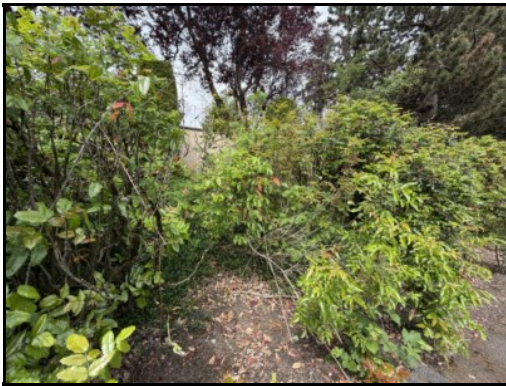
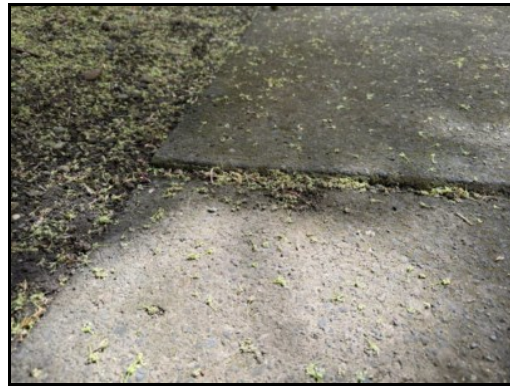
- Sidewalk damage from tree roots will continue to be problematic with the maturing trees that have invasive root systems. We recommend that the Association continue working with a qualified arborist to plan for full tree replacements where damage is occurring.
- The aging of the coping and plaster of the CMU walls is allowing water intrusion that causes blistering and discoloration of the walls.
- Encroachment of the trees on the CMU wall and over sidewalks was observed.
- The landscaped area along 162nd had an unkempt appearance that could encourage further damage.

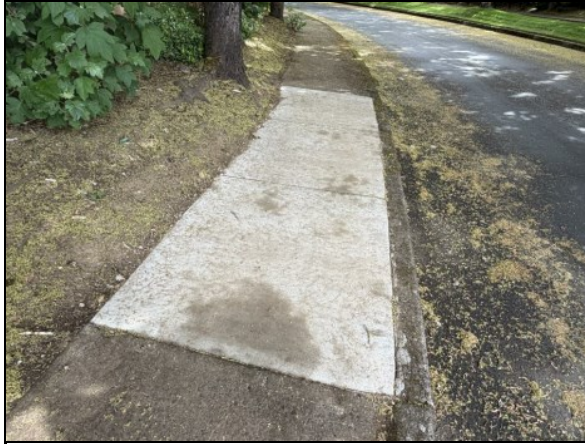
**Comp #: 101 Concrete - Repair/Replace****Approx Quantity: 9,500 SF****Location:** Common Area sidewalks (community entrances, along NE 162nd Ave): ~1,900LF**Funded?:** Yes.**History:** 2024: 220LF sidewalk replaced @ \$18.6K;**Comments:** The Association reported repairs of the concrete sidewalks in 2024, representing roughly 10% of the surface area.

Due to the maturing trees with invasive roots, general age and eventual wear, we suggest a periodic funding allowance to supplement the operating budget for periodic large-scale repair/replacements as reflected below.

As routine maintenance utilizing operating funds, inspect regularly, and pressure wash for appearance. Repair promptly as needed to prevent water penetrating into the base, which can cause further damage. Factors affecting the quality of the concrete include the preparation of the underlying soil and drainage, thickness and strength of the concrete used, steel reinforcement (none likely), and the amount and weight of vehicle traffic.

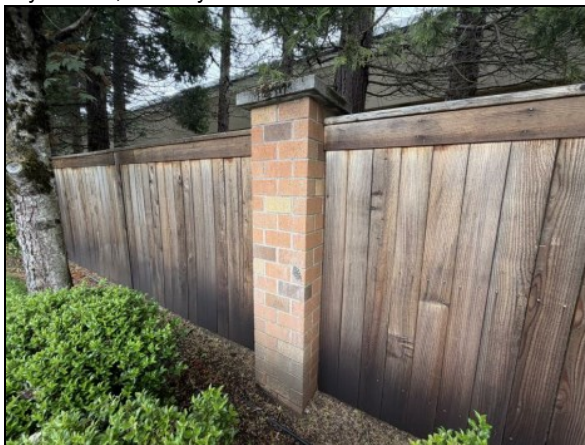
**Comp #: 140 Wood Fence - Repair/Replace**

**Comments:** The fences were replaced in 2021 and appear to have a stain protection. No damage or obvious decay were noted.

Plan to replace the fence at roughly the time frame below. Typical failures occur from deterioration through the end grains, and contact with the ground and surrounding landscape.

As routine maintenance, inspect regularly for any damage, and repair as needed. Avoid unnecessary contact with the ground, sprinkler patterns, and surrounding vegetation. Regular cycles of stain/paint will help to maintain appearance. Painting or staining the fence has a higher overall life cycle cost, but may extend life in addition to an aesthetic benefit.

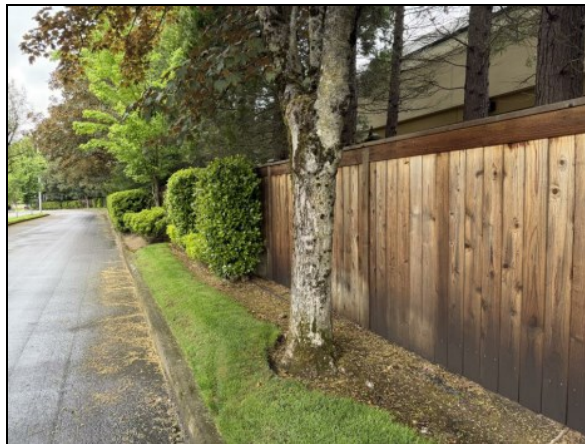
**Comp #: 142 Wood Fence - Clean & Stain**

**Comments:** The wood fence appears to have a semi-transparent stain. No bare wood was observed. Darkening at toward the bottom of the pickets may be from the stain application or interaction with splash from the rain.

Regular sealer applications are recommended for the appearance, protection, and maximum useful life of the wood. Actual timing of staining will vary based on exposure, and quality of material and application. In our experience, quality solid-bodied stain typically produces the best result. Remove any unnecessary contact with the ground, surrounding landscape, and sprinkler patterns. Repair as needed, and clean prior to sealer application.

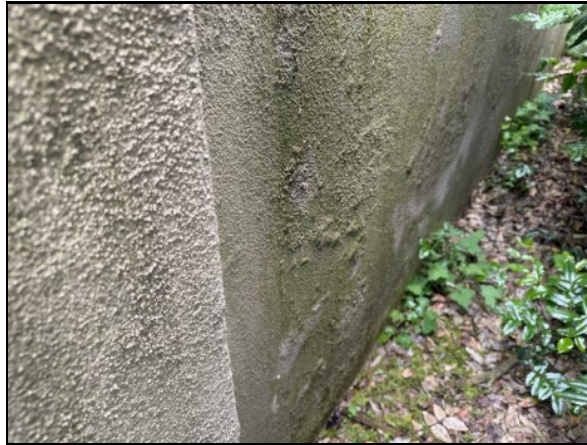
**Comp #: 157 Plaster/CMU Walls - Maintain/Repair****Approx Quantity: 2,600 LF CMU/Plaster****Location:** South & East perimeters of community**Funded?:** Yes.**History:** 2019: 800LF repairs \$21K by Apex; 2018: 800LF repairs to plaster and metal coping \$52K**Comments:** The CMU walls are coated with painted plaster with metal coping. The Association reported repairs to the plaster and coping due to water intrusion in 2018 and 2019. During our site review, several areas of blistering were noted, which are likely also due to water intrusion. There were no reports of large scale painting and water proofing of the plaster, and areas of grime and organic growth in the plaster were noted. It is anticipated that the wall will require ongoing repairs as the coping and plaster age.

Funding is provided for repairs to 25% (650LF) of the plaster and coping every 10 years for a full repair every 40 years. The Association reported that painting of the wall has recently been done by volunteers as needed. Keep track of actual expenses and adjust future reserve studies as needed.

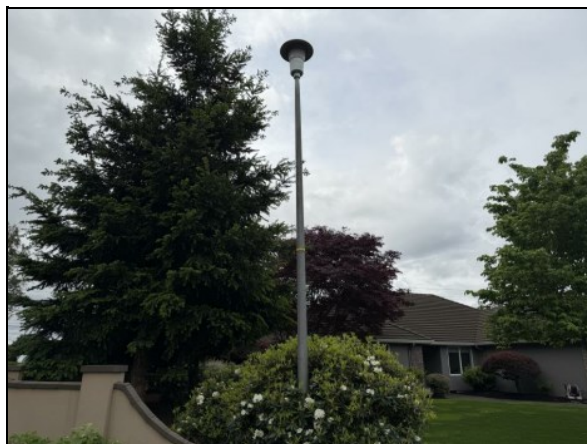
**Comp #: 160 Pole Lights - Repair/Replace****Approx Quantity: 1 not funded****Location:** Along the public roadways.**Funded?:** No. Maintained by Clark County Public Utilities**History:** Maintained by Clark County Utilities**Comments:** The pole lights are along public streets and are maintained by Clark County Public Utilities. No reserve funding is required.**Useful Life:****Remaining Life:**

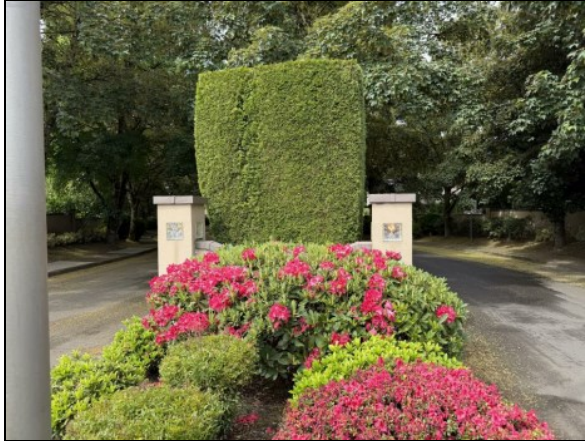
**Comments:** The landscaping at the entrances appear to be professionally maintained within the operating budget. New shrub plantings and renovations were noted. The landscaping along NE 162nd Avenue appears to be minimally maintained and shows areas of neglect with bare areas that have grown brambles and weeds, overgrowth of trees with limbs in contact with the wall.

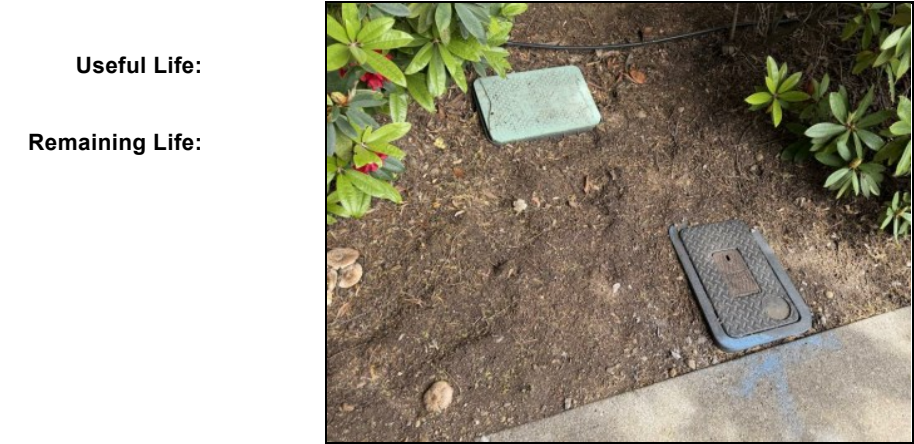
**Comp #: 173 Irrigation System - Repair/Replace**

There are no predictable large-scale costs at this time. Have your landscaper or irrigation specialist periodically unearth sections to check lines for any damage or deterioration. PVC can eventually become brittle and leak (typically not before the 40 year mark of life).

As routine maintenance, inspect, test, and repair the system, as needed, as part of the operating budget. Follow proper winterization and spring startup procedures. If properly installed and bedded without defect, the lines could last for many years. Controls for the system can vary greatly in number, cost, and life expectancy - typically each controller is less than \$500. Other elements (i.e. sprinkler heads, valves) within this system are generally lower cost, and have a failure rate that is difficult to predict. These elements are better suited to be handled with operating funds, not reserves.
